Cold Creek at High Meadows Stream Channel and Floodplain Restoration Project

Second Year Post-Project Monitoring Report

February 2015

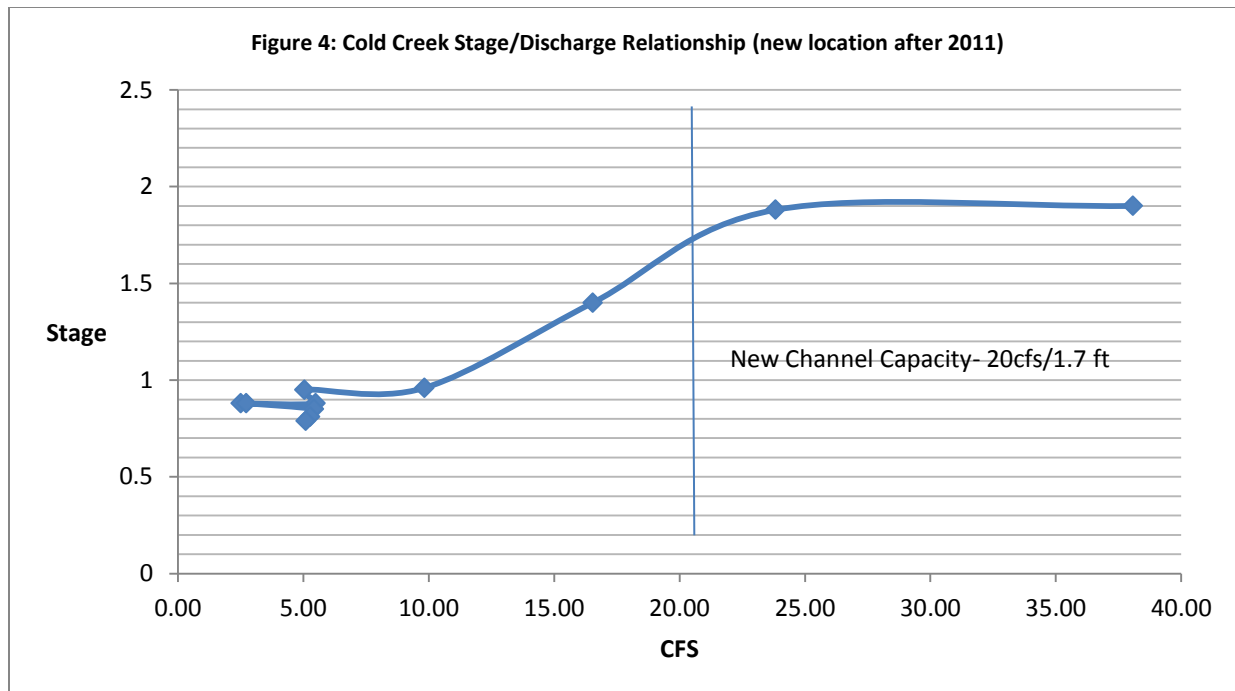
The channel capacity of the main channel pre-project and post project was calculated from cross section data on both the pre-project and post project channels, utilizing procedures contained in the Rosgen Field Guide (Rosgen, 2008). Based on these calculations the volume of flow (cfs) at which the flows exceed the channel capacity and begin to spread out onto the floodplain was 53 cfs in the old main channel, and 20 cfs in the new main channel. From an analysis of measured data, flows did not exceed channel capacity in the old channel during the period of record from 2003 through 2014, with the exception possibly of 2011. Although our rating curve is not accurate enough to confirm, it does seem likely that flows entering high meadows may have exceeded 53 cfs for a substantial period of time during this high water year. Post project, overbank flows in the new channel above 20 cfs have not occurred during the two dry years following construction, with the exception of a 3 day storm that occurred in February of 2014, in which stage was recorded up to 2.12 feet.

Although a longer period of record is needed to document frequency and magnitude of overbank events in the new channel during average and wet years, it is clear that overbank flooding will increase substantially as a result of reducing the channel capacity by 63% (53 cfs to 20 cfs). Based on data contained in Table 2, we conclude overbank flows would have occurred during water years in which May precipitation totals exceed about 27 inches (five out of the last 12 years).

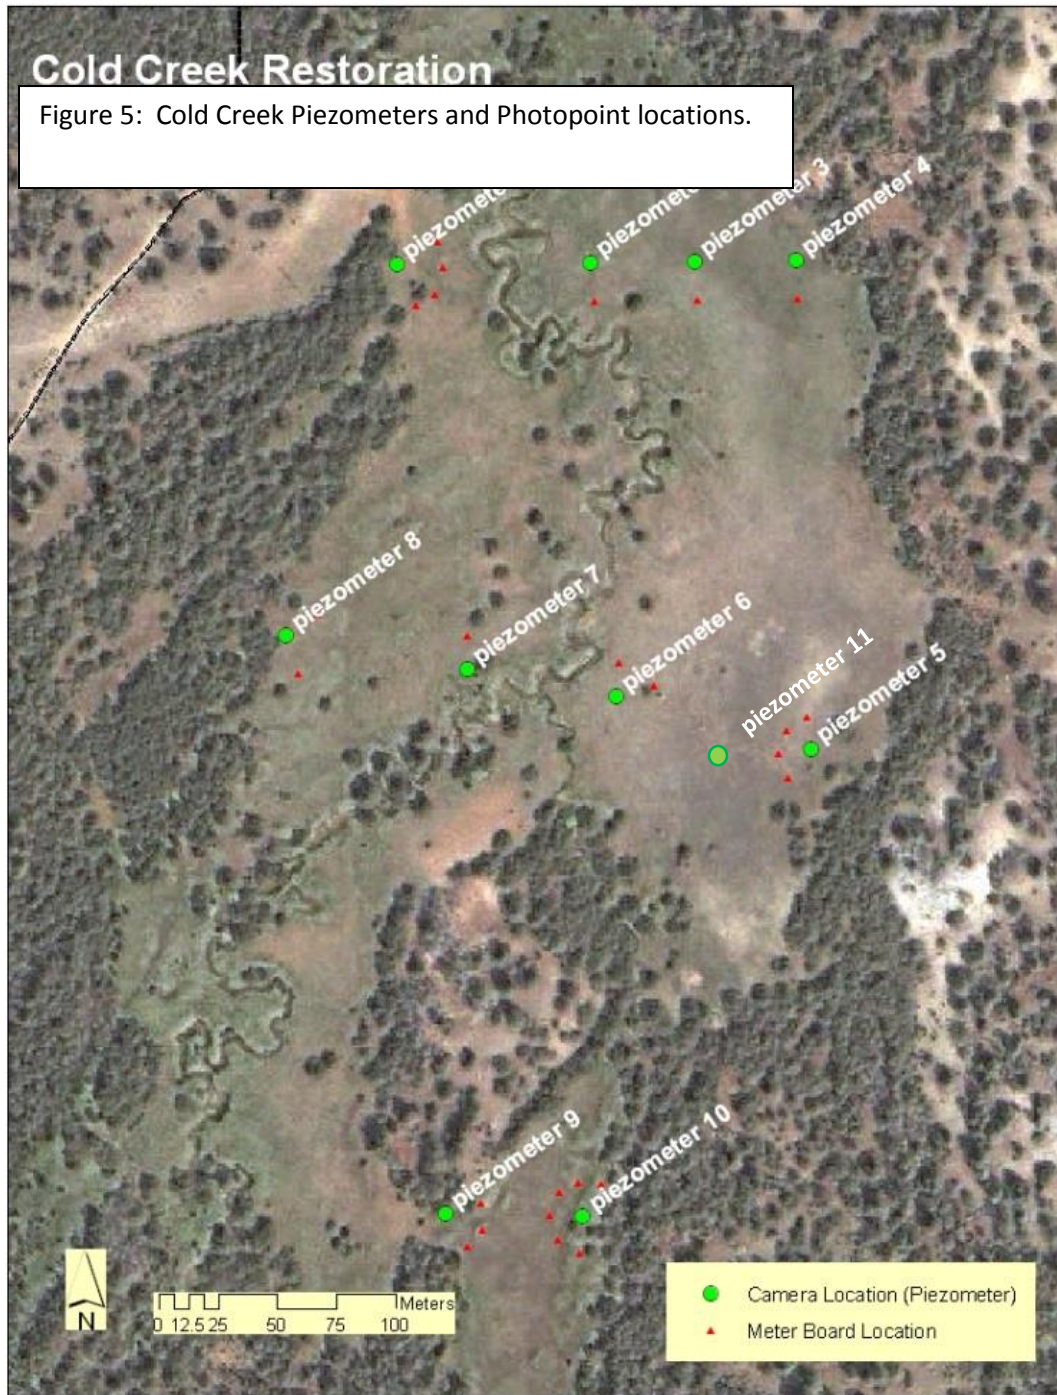
Figure 5: Cold Creek Piezometers and Photopoint locations.

A total of 11 wells were monitored, and the locations of these wells relative to the old channel are illustrated on Figure 5. They essentially are positioned in 3 transects, transect one (wells 1 through 4) across the bottom half of the main meadow, transect 2 (wells 5, 11, 6, 7, 8) across the upper half of the main meadow, and transect 3 (wells 9 and 10) located in the bottom half of the middle meadow. Well 11 was added later than the other wells, accounting for the odd numbering sequence within transects.

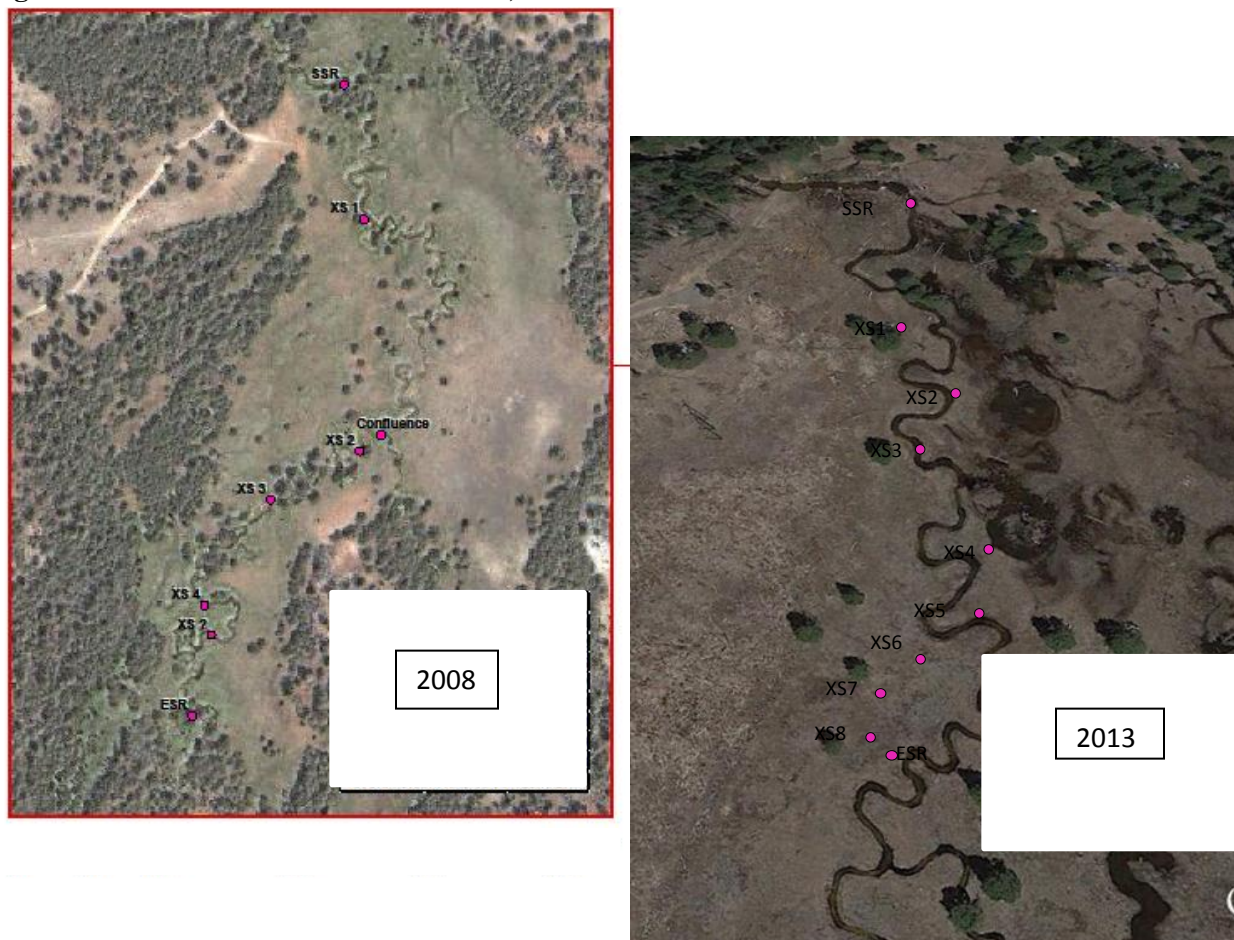
Figure 6: Locations of SCI measurements, 2008 and 2013.

A variety of data was collected to evaluate the degree to which stream channel condition has improved as it relates to channel geomorphic stability and aquatic habitat quality, utilizing USFS Region 5, Stream Condition Inventory (SCI) Protocols (USFS, 2005). The metrics collected and analyzed include bank stability ratings, sinuosity, width/depth ratios, entrenchment ratios, pool/riffle ratios, residual pool depths, and particle size distribution. In this report metrics collected in 2008 in the old channel prior to restoration, are compared to measurements collected in 2013 in the new mainstem channel. The location of the two SCI reaches is also illustrated on Figure 6. The results of stream channel condition monitoring for most metrics are summarized in Table 3 below.

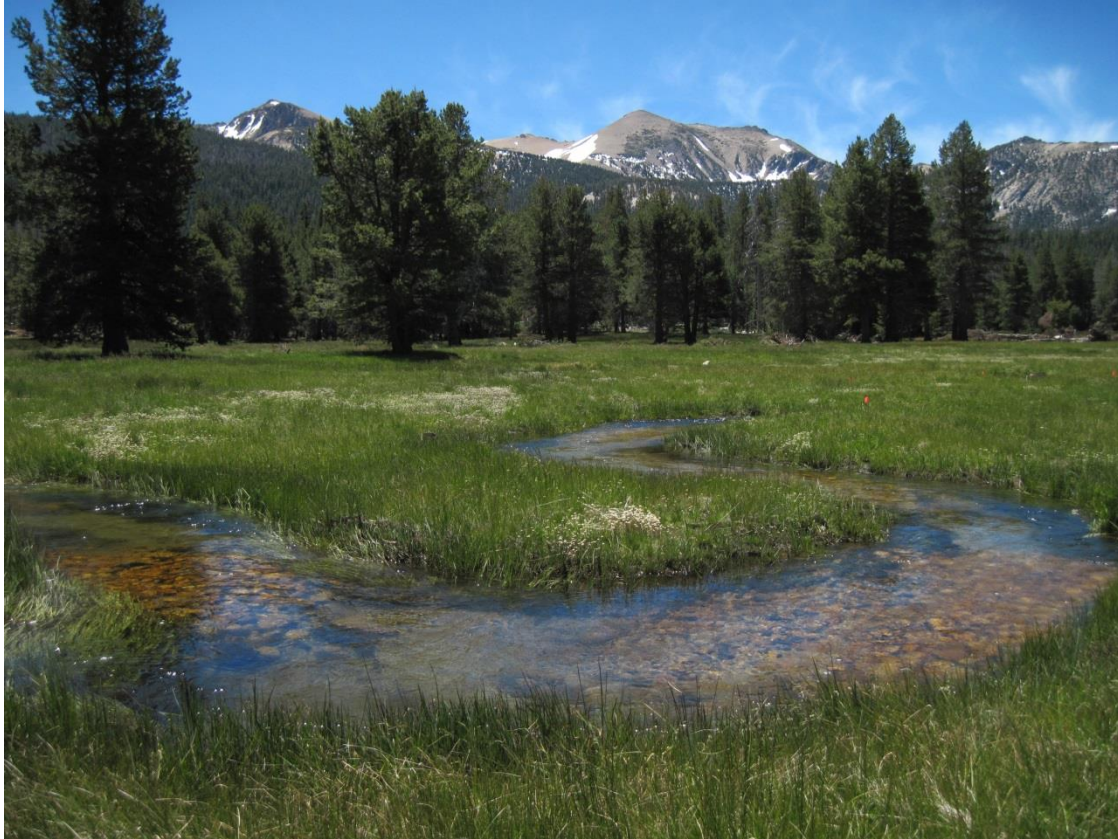
Figure 7: Cold Creek in High Meadows, new main channel, 2013.

The photo below is representative of the condition of the main channel banks, illustrating the success of sod harvesting in quickly establishing stable vegetative cover.

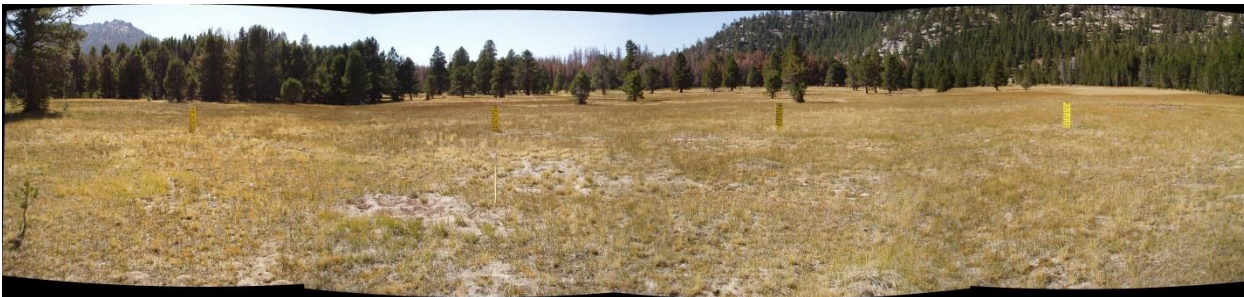
Well 1- Panorama 1, September 2014

LP mortality because of increased GW

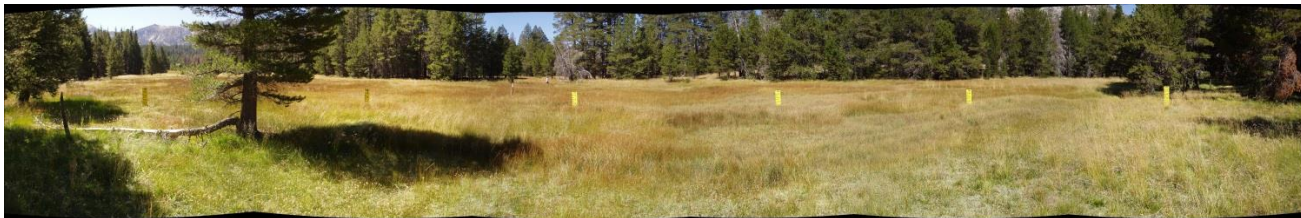
Well 5 -Panorama 5, September 2014

NF inset floodplain
